## Catastrophic water contamination of a Marine based Ammonia Refrigeration system

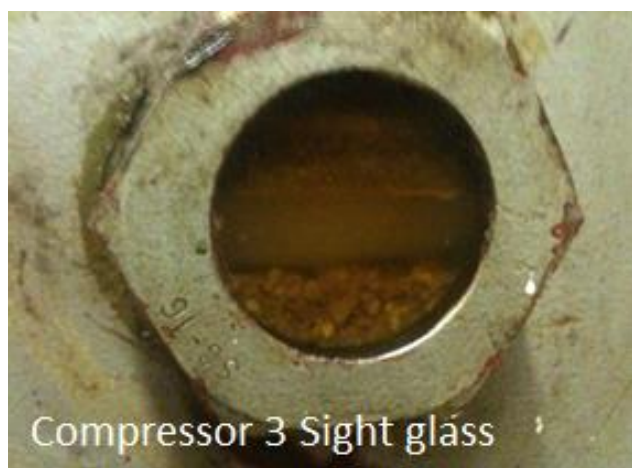
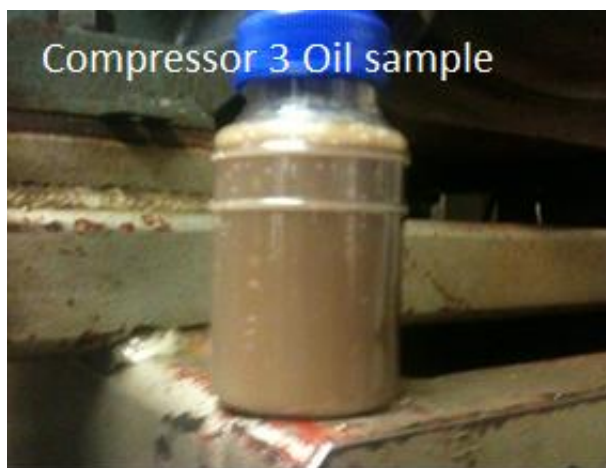
My first visit to the plant room was something extraordinarily special, the noise was like a microwave full of spoons. It was so abrasive it forced me to wear ear plugs beneath my grade five + hearing protection, If I had of heard the compressors running anywhere else, I would be diving at the emergency stop but knowing that there was no redundancy and almost four million New Zealand dollars' worth of Skip Jack Tuna on board, I slowly backed out of the plant room like I had mistakenly walked into a gang headquarters with the wrong colours. Immediately I requested some jars for oil sampling, after noticing layers of separation and 'chunks' of what I could only presume were crystals in the oil separator sight glass of Compressor number 3.

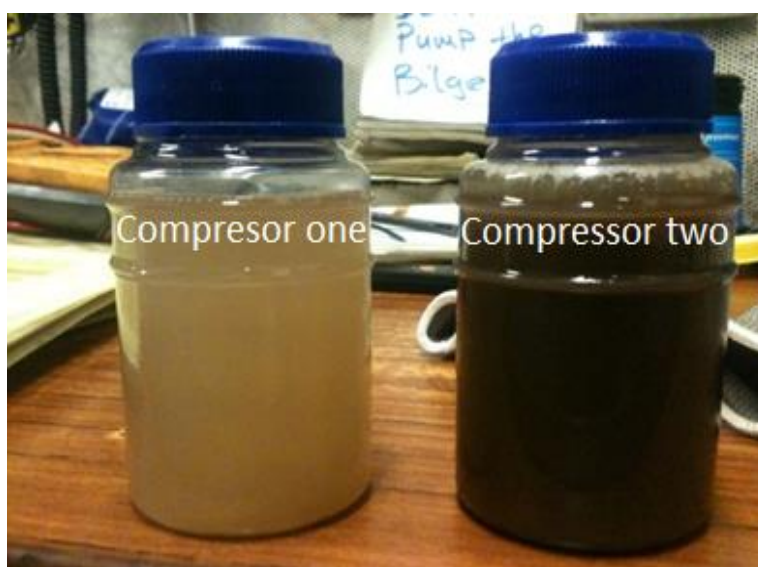
To my amazement, a strange pink ooze was sampled from compressor three, Number one was thin and cloudy and number two was thick and black. It was clear to say that these compressors would not spin for much longer. I had experienced water contamination many times before but this was unreal. Having just landed in American Samoa less than an hour earlier I was still trying to get acclimatise to the place, let alone the heat of the situation I was in.

From the lubricant samples I examined. I swiftly advised the Captain to make plans to transfer the product before they lost it all due to fatal compressor failure. At this point in time it was not even an option to change oil, as there was none.

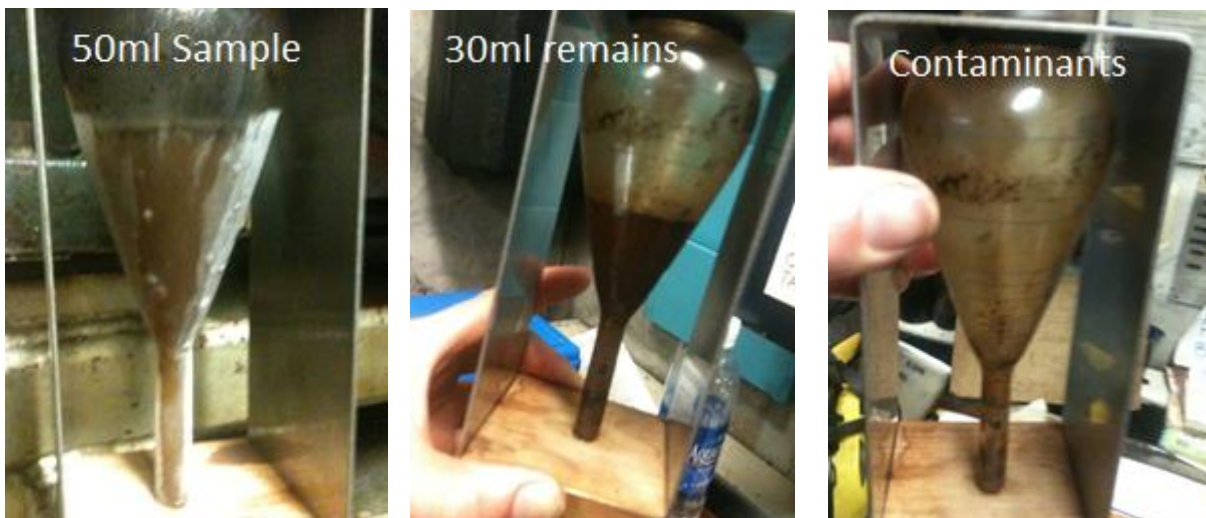
I proceeded to sample Ammonia from the LP accumulator number two. After draining approximately 20 litres of what could only be described as diarrhoea flavoured ice cream. 50 ml of Ammonia was drawn, a final result of 30 ml of highly contaminated Ammonium hydroxide ( $\text{NH}_4+\text{OH}$ ). This system contained a serious amount of water along with a bunch of other nasties. This had no doubt confirmed the water ingress.

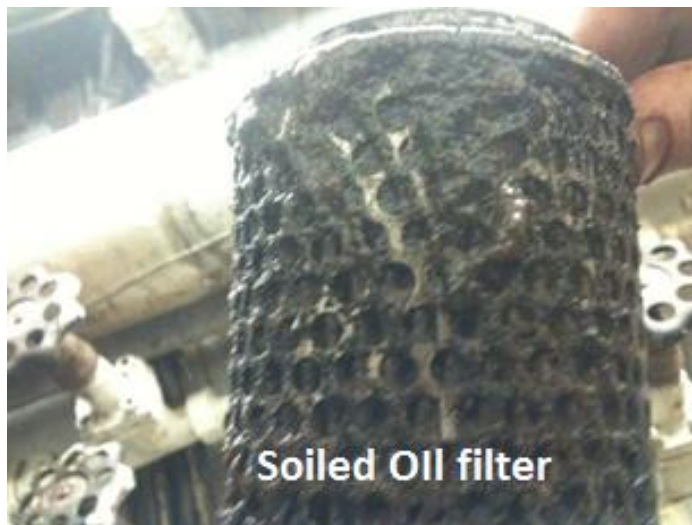
**Soiled Oil filter**

On inspection of the UNISAB controllers I had identified that the oil pressure cut outs had all been re-calibrated to bypass oil failure. I changed the filters one by one and found each severely blocked with the same ice cream as previously mentioned.

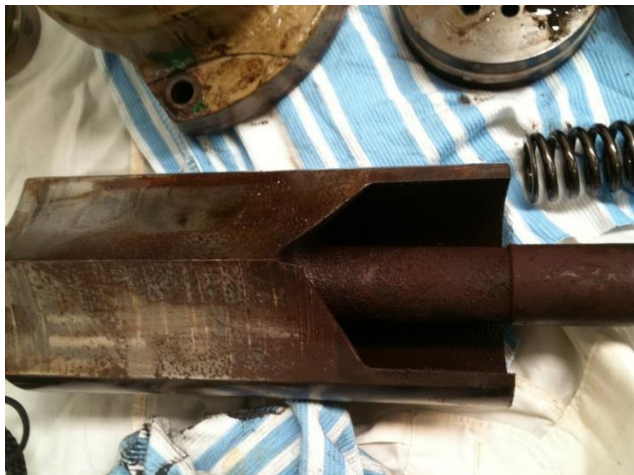
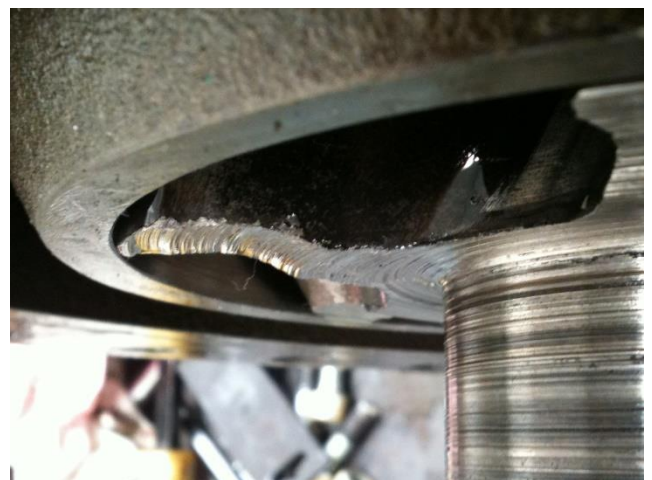
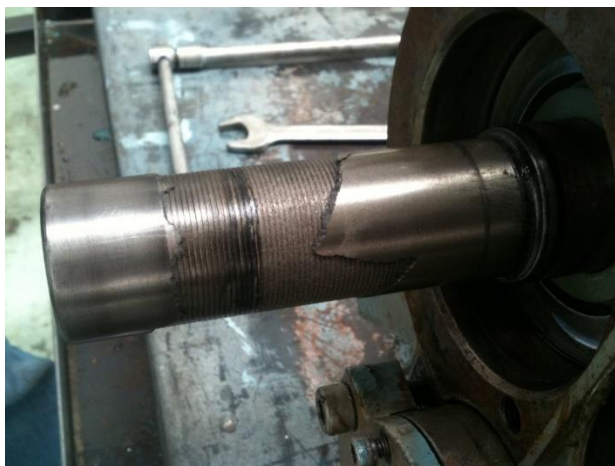
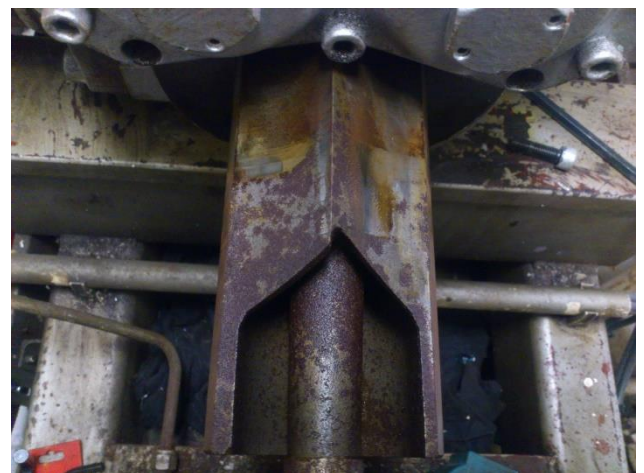
In the following weeks we received a large wooden box full to the hilt of corroded and highly damaged compressor parts in which we were asked to overhaul.

Between three of us it took over a week to clean before we could even begin assessing the damage.

The compressors were no longer available from the manufacturer so we made one machine out of three compressors and sourced the other two from abroad.

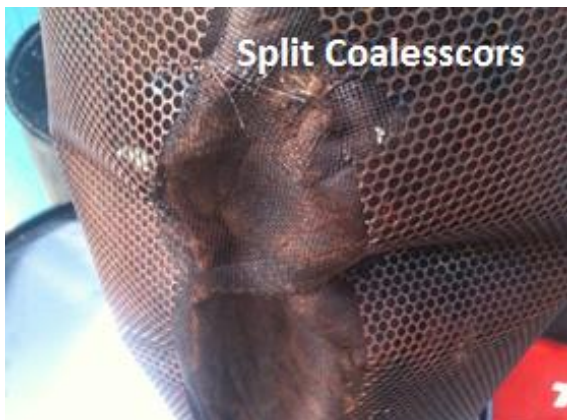
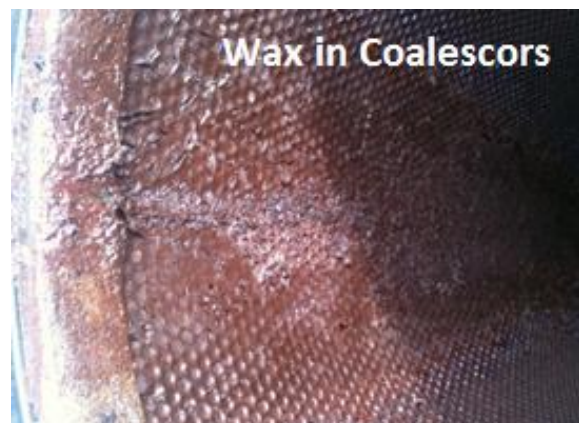
Whilst the rest of the system was evacuating we took the opportunity to remove the Coalescors, noticeably there was a few issues.

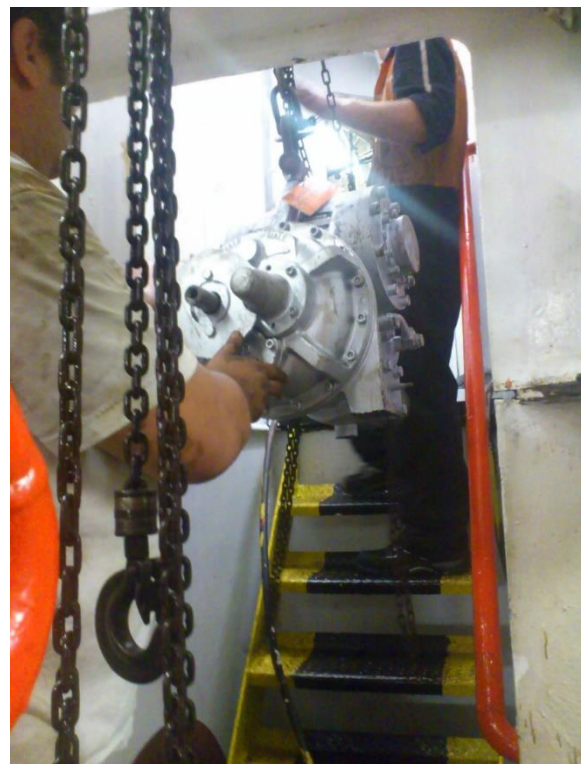
The vessel eventually returned to Port for some much needed special attention. The first thing I noticed on arrival was the Oil pressure safeties were bypassed yet again!

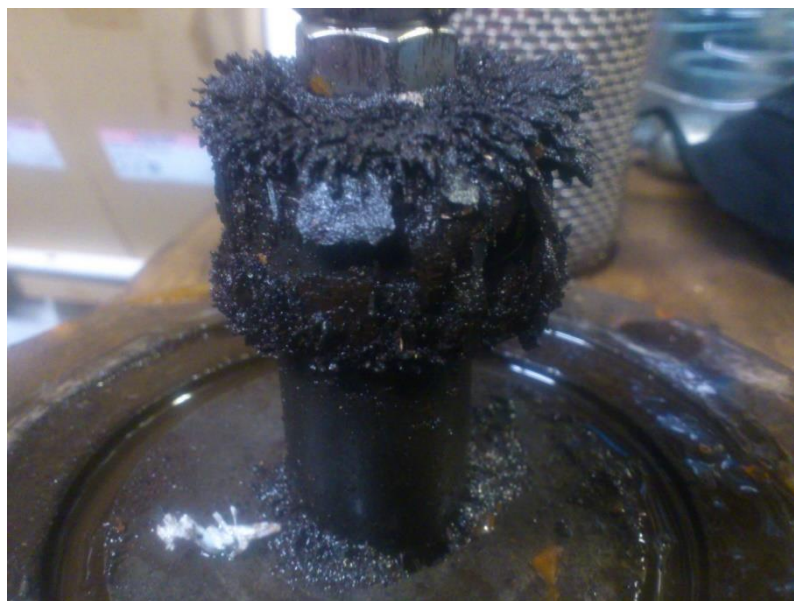
The Oil separators were probably the most challenging, the images do not provide the scale of the contamination with enough justice, the thick layer on the wall of the vessel reasssembled that of a septic tank. Not only were we tasked with inventively cleaning them we were only able to access them through a 2" port.

I commenced the experimentation firstly with solvents with very little success, without agitation, it was hopeless. I tried to mop it as best as possible with a rag on a stick, envisioning that Friends episode where Ross massages a big sweaty guy in a similar fashion.

I manufactured a purification set using a pneumatic pump and a 10-micron filter and had a second attempt, there was an improvement but nothing to rave about. I took a sample to a chemical engineer who suggested Sulphatic acid. This next level approach worked a treat! A little too well, the sludge was gone, but it was causing oxidation on everything above the tideline, fearful of causing further damage I used oil for the remainder of Compressor three with the aid of removing any contaminants as well as providing the wall of the vessel some much needed lubrication.

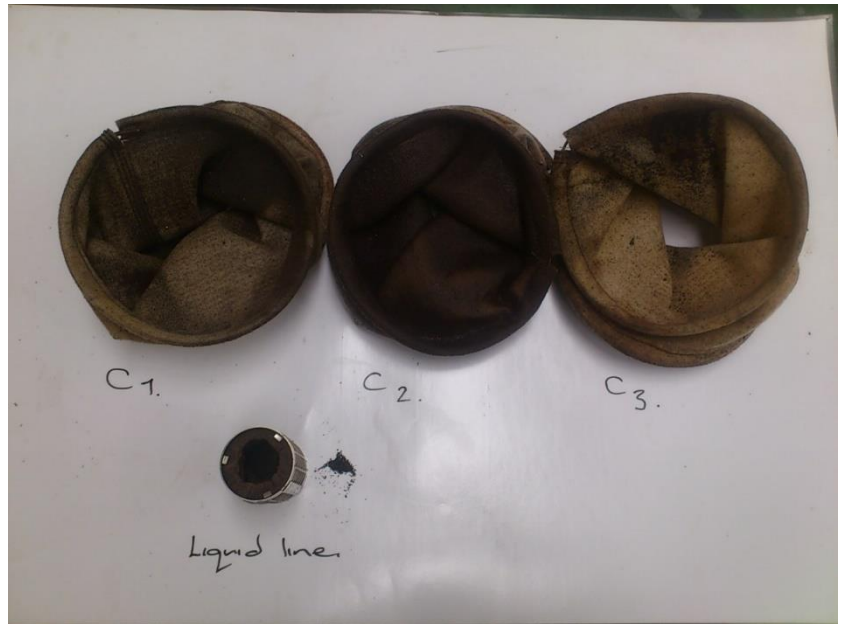
At around 100 hours we removed all the commissioning filters, which were all pretty badly soiled. The liquid line was inspected a further 100 hours later however produced no visual contaminants. This fact alone is why when I commission a land based system & find excessive foreign material I tend to question the quality & care of the installation. If a filthy catastrophically failed system can be cleaned with degreaser & stripped back to bare bones & produce these results, there is no viable reason to have any level of contaminants in a new installation.
