## Catastrophic water contamination of a Marine based Ammonia Refrigeration system

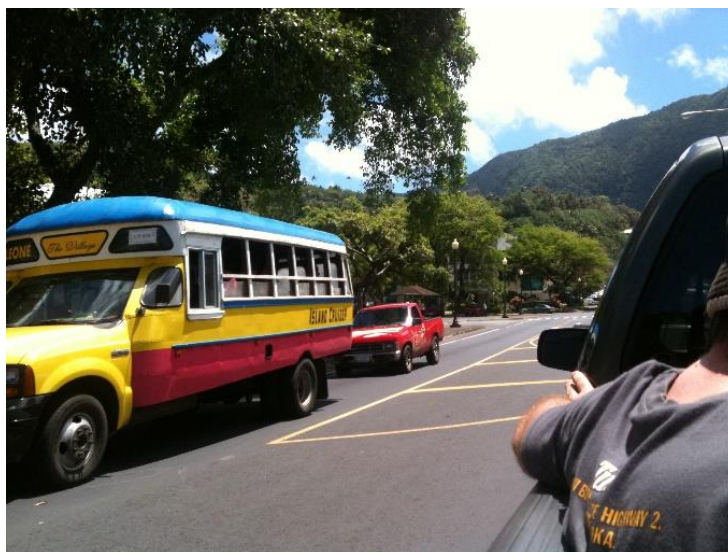
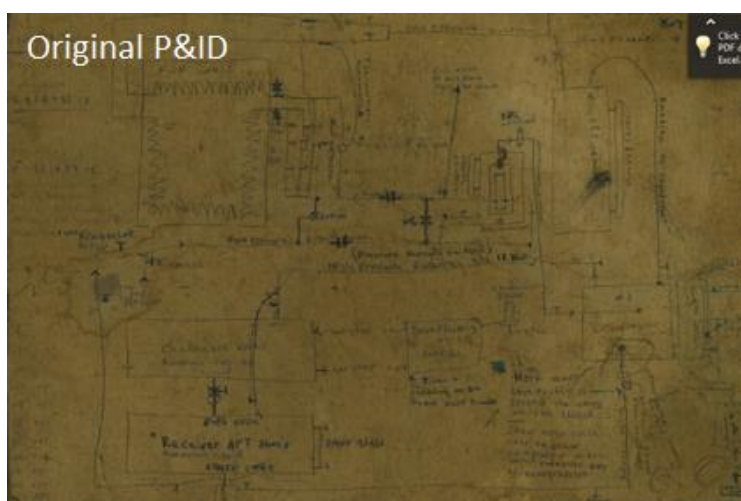
I then went to work to make the best of a dire situation... The system consisted of three Sabroe 128 compressors running in a single stage economised configuration. They were running a primary sea water, secondary circuit fresh water oil coolers as well as HLI liquid injection via Danfoss TEAT valves. The static evaporators were fed by both hand regulation and what they called Automatics (thermal expansion valves) the network of Ammonia pipework had been installed to provide as much redundancy as possible.

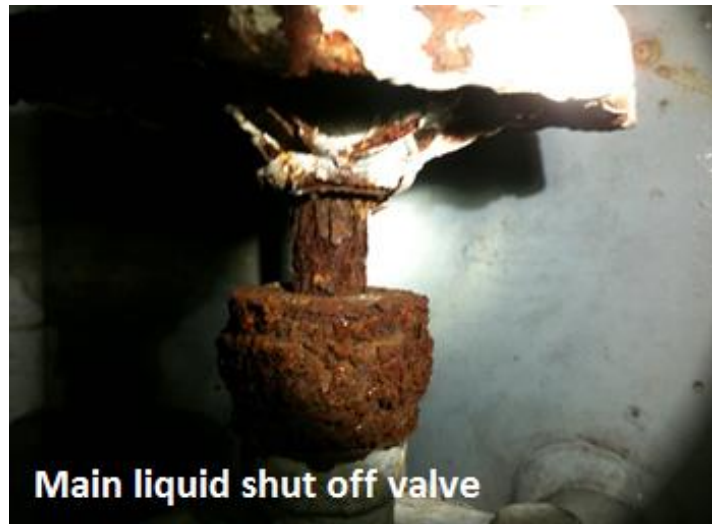
Again I left a step by step procedure with the vessel. This primarily consisted of regular oil changes and Ammonia purification as many times as possible until it was clear. The vessel was lucky enough to have an intermediate pressure plate heat exchanger which was dedicated to the Accommodation air conditioning system. We decided to utilise this as the purifier.

A purifying cycle was simply completed by isolating the liquid Ammonia supply and allowing to pump out the then draining off any contaminants.

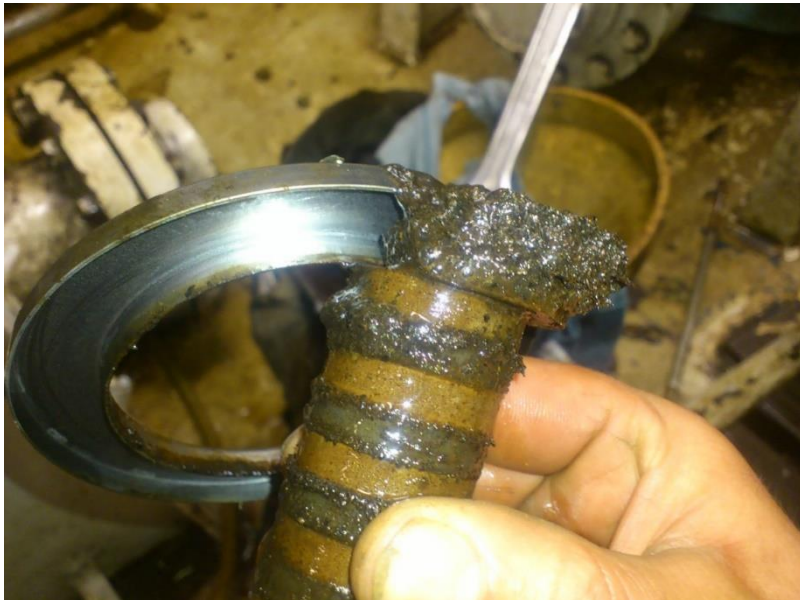
Every asset was overhauled on-board so we were constantly waiting & working around other contractors. Something I was used to having completed five other retrofits but frustrating all the same. We were able to make a good hit on the engine room early on which is what I found the most interesting The sludge! I have never experienced so much. It was un imaginable & eventually became laughable. All low points were drained and every valve and component were overhauled.

Extra filters were fitted to the compressors and eventually the liquid line was provided with an ancillary commissioning filter. Every filter was additionally fitted with magnets for removal of any ferrous material.

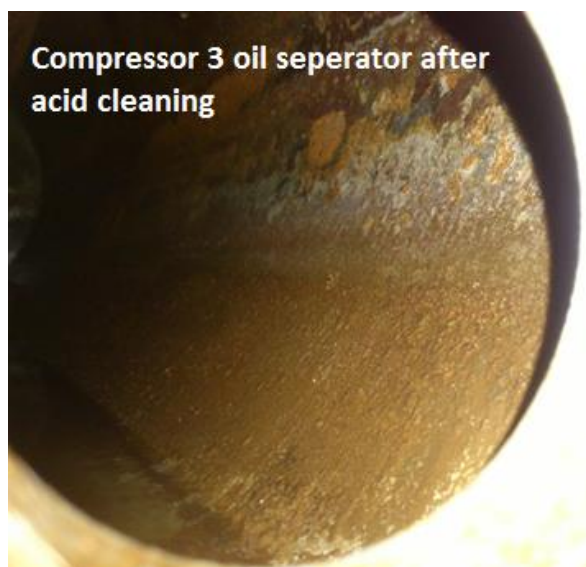
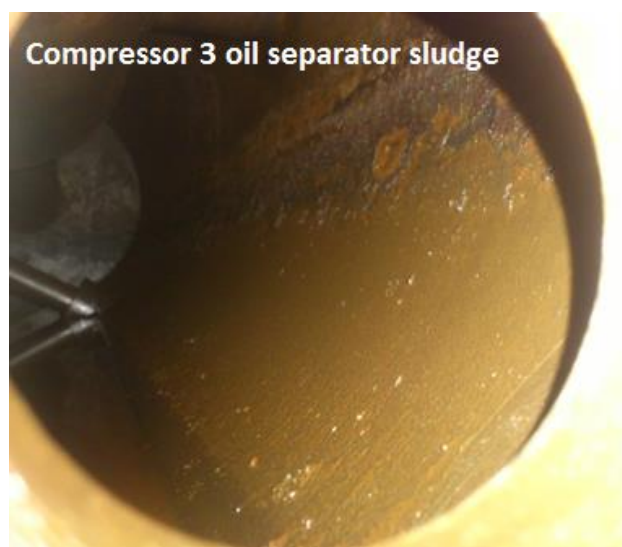
I manufactured a purification set using a pneumatic pump and a 10-micron filter and had a second attempt, there was an improvement but nothing to rave about. I took a sample to a chemical engineer who suggested Sulphatic acid. This next level approach worked a treat! A little too well, the sludge was gone, but it was causing oxidation on everything above the tideline, fearful of causing further damage I used oil for the remainder of Compressor three with the aid of removing any contaminants as well as providing the wall of the vessel some much needed lubrication.

I successfully utilised sodium hypochlorite degreaser on Compressor two, this performed well and since it was not volatile or so corrosive it was much more user friendly.
